**OHIO RIVER BASIN  
UNNAMED TRIBUTARY TO HARMON CREEK, WASHINGTON COUNTY  
PENNSYLVANIA**

**PHASE I INSPECTION REPORT  
NATIONAL DAM INSPECTION PROGRAM  
PACW31-FO-C-0025**

**July 1980**

PA 480, Washington County, Pennsylvania  
NDI No. PA 01125, PennDER No. 63-84, SCS No. PA 480  
Unnamed Tributary to Harmon Creek  
Inspected 27 March 1980

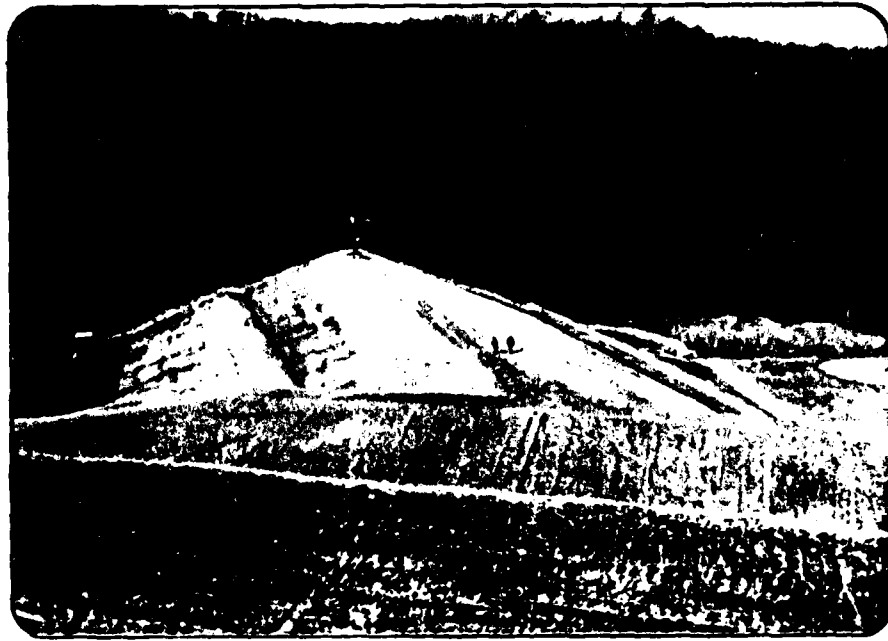
Overall View of the Upstream Face of the Dam from the Right Abutment

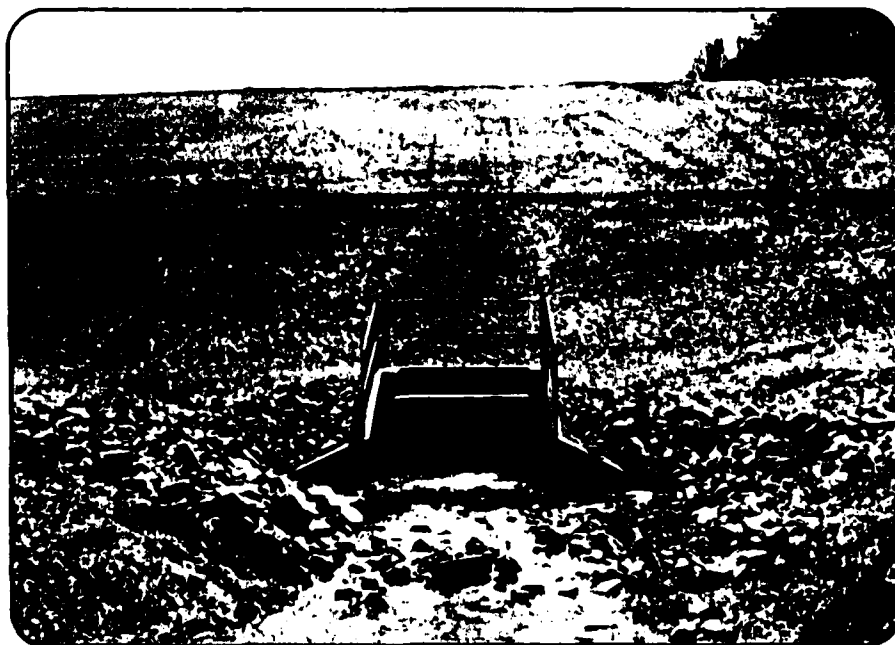
PHOTO 2. View of the Impact Basin

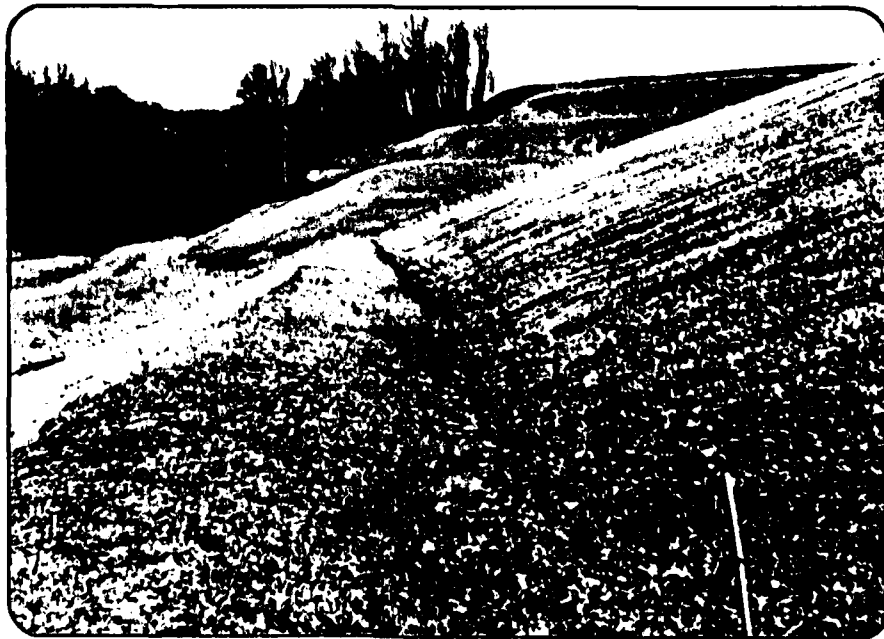
- 3) Some ponded water was observed on the bench on the downstream side of the embankment. Several areas on the embankment below this bench were relatively saturated. Because the

Several minor seeps were observed on the right abutment above the emergency spillway. These seeps, none of which were flowing more than 1 g.p.m., are the result of groundwater flow. There was some ponding of water on the bench on the downstream side of the embankment. There were also several areas on the embankment below this bench in which the soil was saturated.

PHOTO 4. View of Water Collecting at the Toe of the Bench on the Downstream Side of the Embankment

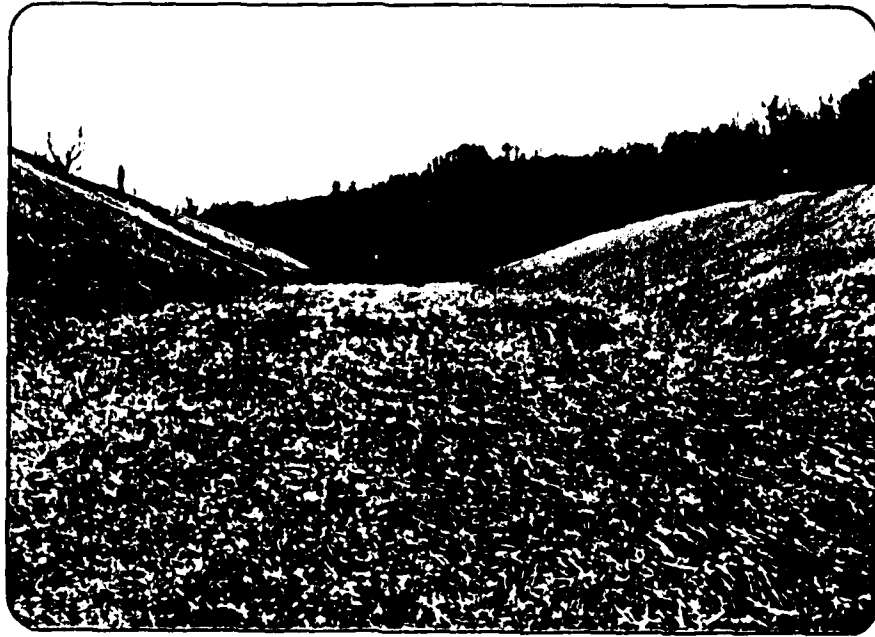
PHOTO 5. View of the Emergency Spillway Looking Upstream

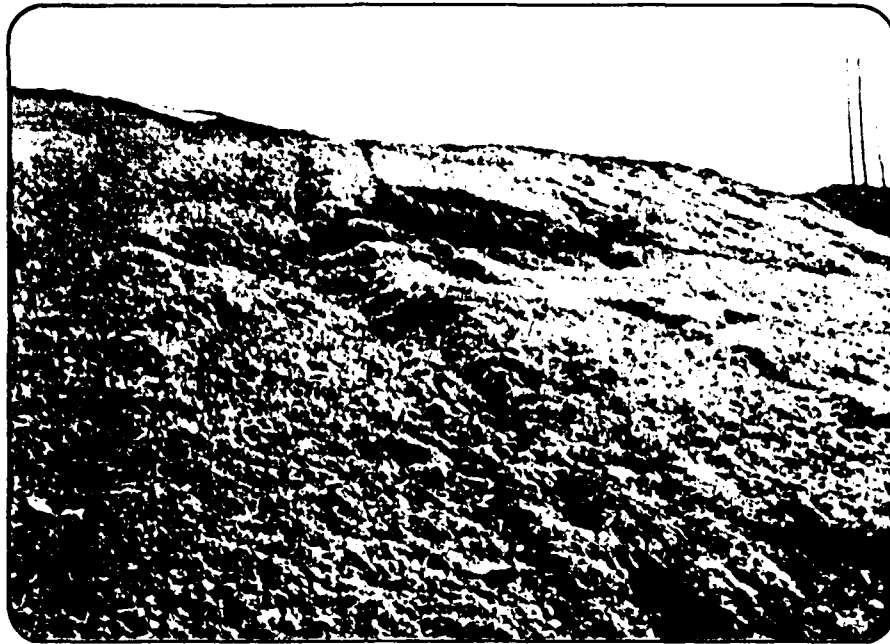
- b. Dam - The following is a list of the minor deficiencies observed during the visual inspection of the embankment and abutments.
  - 1) There are several areas on the right abutment above the emergency spillway where there is some minor erosion and sloughing of the abutment slopes taking place. This problem is at least partially caused by groundwater seepage from the area behind the abutment and exposed zones of soft weathered mudstone. A number of small springs were observed on the abutment, all of which were flowing less than 1 g.p.m. This seepage had saturated the abutment slope in several locations. On the three benches above the emergency spillway, there was some ponded water which probably collected during recent rainfall. This condition is not believed to be a serious problem at the present time.

The minor sloughing of the right abutment is not considered to be a significant problem since the abutment has 11 ft. wide benches placed at three elevations. The small slump at the end of the emergency spillway is also not considered to be a significant problem at this time. The erosion channel should be repaired.

**PHOTO 7. View of the Slumping Areas and Erosion on the Right Abutment  
above the Emergency Spillway**

It is recommended that the seepage and sloughing of the right abutment be monitored during future inspections to ensure that these conditions do not become serious.

It is also recommended that the slumping areas on the right abutment and the small slump at the downstream end of the emergency spillway be monitored in future inspections to ensure that these conditions do not become serious.
